MISSION STATUS BULLETIN

VOYAGER

March 1, 1978

No. 16

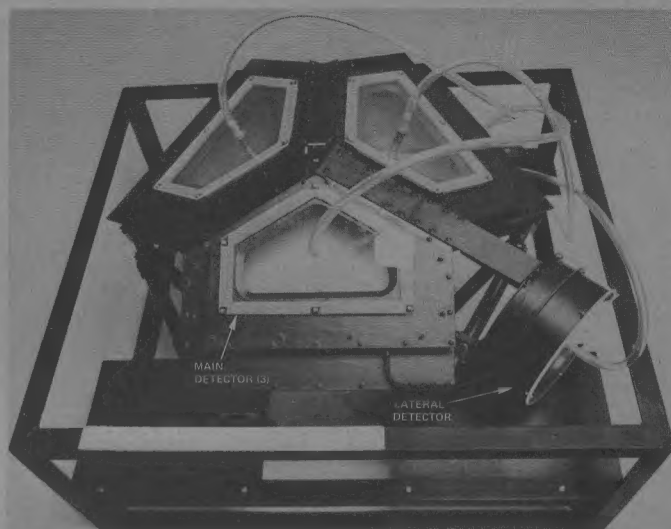
PLASMA INSTRUMENT. The protective covers on the three apertures of the ailing main detector were removed before launch, along with the piping which filtered clean cool air into the instrument before launch. The unaffected side-mounted detector is in the foreground in this photograph.

Although apparently unrelated to the events causing the cruise maneuver abort, a problem in Voyager 1's plasma instrument was also detected February 17. The sensitivity of the main cluster of three detectors appears to have dropped significantly. Initial indications are that the science objectives can still be met at Jupiter; however, during cruise, measurements of positive ions at the lower energy levels in interplanetary space will be significantly affected. The instrument is designed to measure ions in the energy range from 10 to 5950 electron volts. The side-mounted detector, positioned at right angles to the ailing main cluster (which points toward Earth), is unaffected and working as planned.

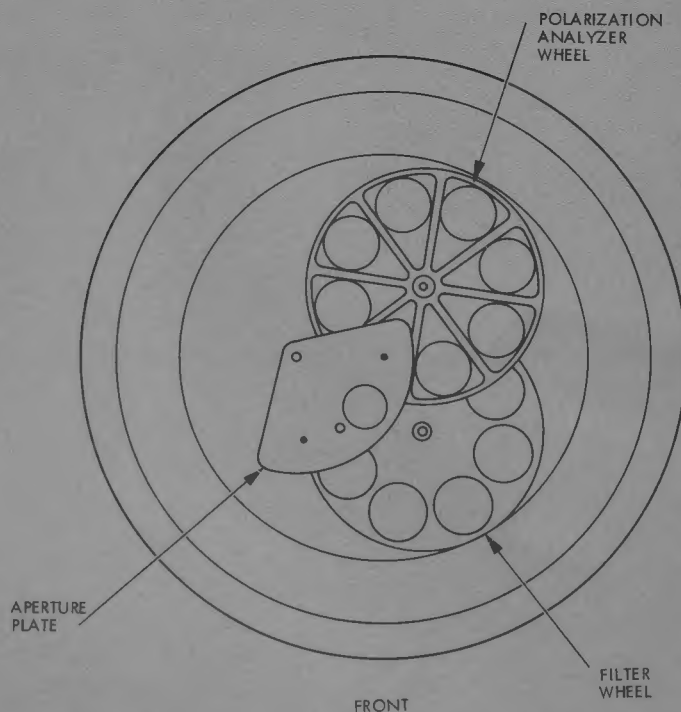
Voyager 2 presented a not altogether unpleasant surprise when it was detected that the stuck analyzer wheel of the photopolarimeter instrument appears to have become unstuck and operable. The wheel, stuck since shortly after launch, appears to be stepping properly, but further study is needed before concluding that the instrument is operating normally again. At nearly the same time, the filter wheel began to display erratic behavior, and the instrument has now been turned off until these latest developments can be understood. The normal operating mode of the instrument is to step through 40 filter/analyzer wheel combinations once every 24 seconds to provide intensity and polarization measurements of scattered sunlight at selected wavelengths.

PHOTOPOLARIMETER (PPS). In the normal operating mode, the instrument steps through 40 filter/analyzer wheel combinations every 24 seconds.
